Trouble Shooting List				
No.	Subject	Model	System	Remark
1	Intermittent engine check lamp on / engine hesitation	DI All	D27DTP	
2	Cooling Fan Noise at Cold Start	RV All	DI Engine	
3	DI Engine Cylinder Head Gasket Leakage	Actyon	D20DT	
4	Turbo Charger Whistle Noise at Accelerating	Actyon	D20DT	
5	REXTON II CDPF EGT Sensor Removal/Installation	Rexton II	D27DTP	
6	Engine Hesitation after First Delivery	RV All	EURO IV Engine	
7	Rework Procedure for DI Engine Oil Pan Leak	C/D/Q-Car	D20DT	
8	Troubleshooting for DI Engine Alternator Noise	RV All	DI Engine	
9	Installation Notice for Air Cleaner Assembly	C/D/Q-Car	D20DT	
10	Modification of DI Fuel Tank Vent. Tube	C/D/Q-Car	D20DT	
11	DI Engine Cylinder Head Cover Gasket Leakage	Y/C/D/Q	Engine	
12	E-EGR & Throttle Body Initialization	RV All	EURO IV Engine	
13	Engine Noise Come inside Vehicle	A/Sports	D20DT	
14	Engine Power Lack at Accelerating	C/D-Car	D20DT	
15	Engine Check Lamp ON caused by HID Modification	Rexton II	D27DT

Intermittent Engine Check Lamp On & Engine Hesitation

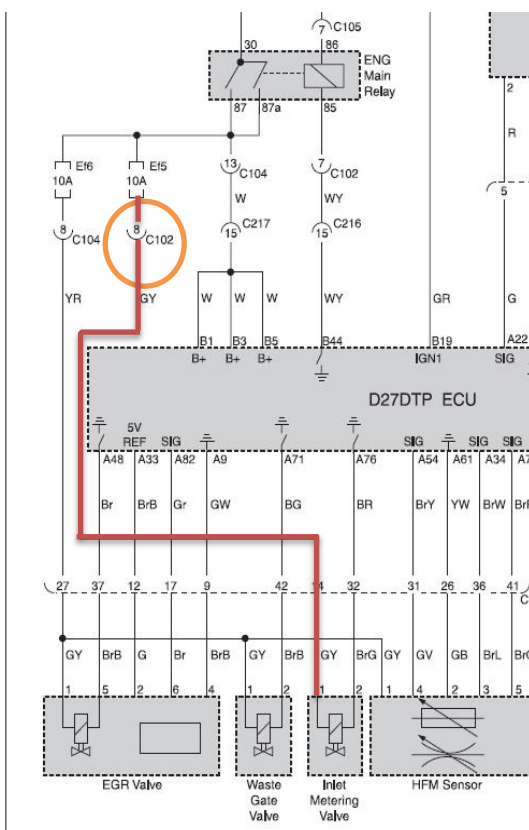
► EWD for Rexton II D27DTP

Poor contact on C102 Pin no. 8 of engine room fuse box

This symptom was caused by poor contact of connector pin of IMV power line, please check related wiring before fuel system replace

Repair the connector pin and symptoms cleared

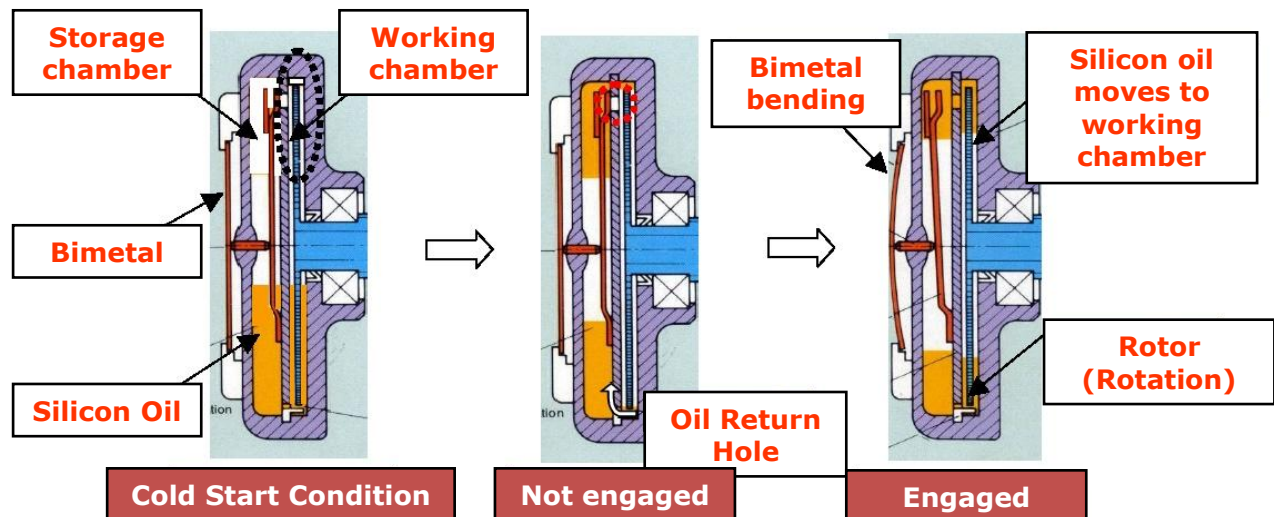
This noise is operating sound of viscous clutch at engine cold start condition□

Especially, in case of long time parking, silicon oil exists in the working chamber□ Refer to the operating□ principle of viscous clutch

Viscous is engaged by the friction force of viscosity of silicon oil

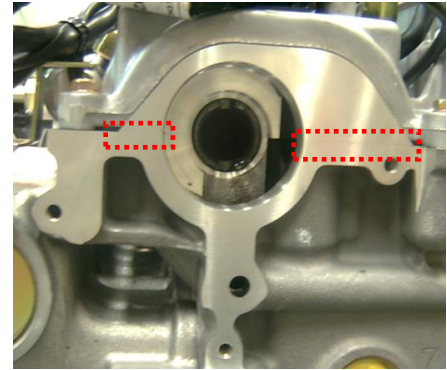
If there is oil leak around cylinder head gasket on DI engine, firstly check leak from vacuum pump

SYMC engine inclines to right side about 15 degrees, so leaked engine oil can move to front side of cylinder head gasket (cylinder No.1) at driving condition.
Please don't make misjudgement cylinder head gasket to oring of oil leak

Check the origin of oil leak at engine idle and driving condition using certain developer (white material)

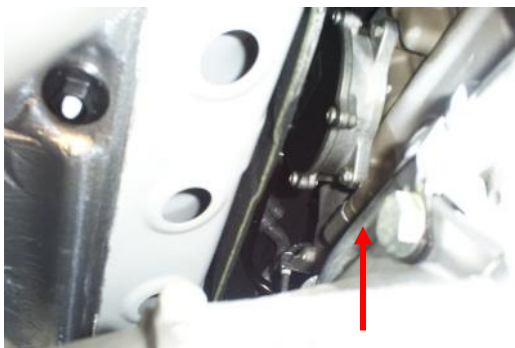
1. Check oil leak of vacuum pump on the naked eyes

Oil leak should be checked firstly

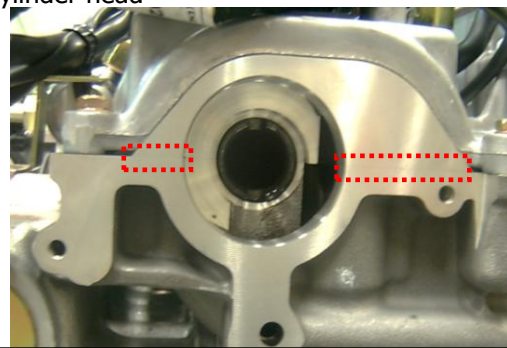
2. Check the matching face of intake camshaft cap and cylinder head

Spec. of matching face (gap)
: **within 0.03mm**

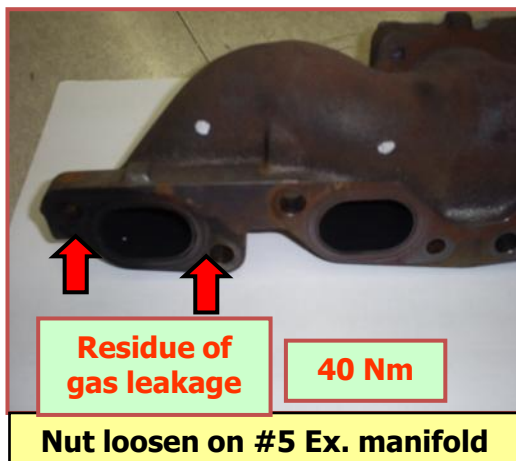
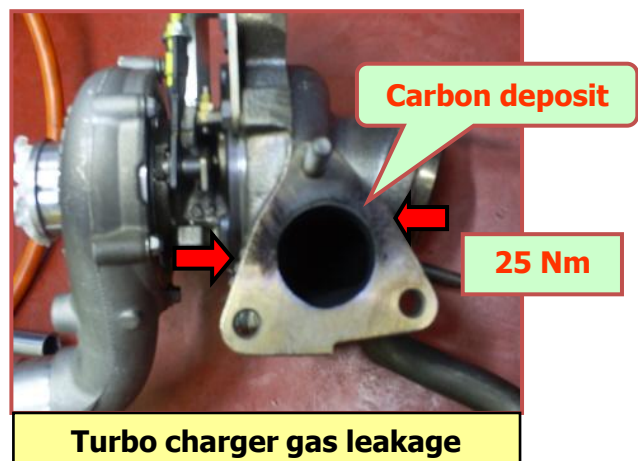
Turbo charger noise caused by gas leakage from turbo charger mounting area and loosened exhaust manifold

Retightened #5 exhaust manifold and clean the carbon deposit of turbo charger

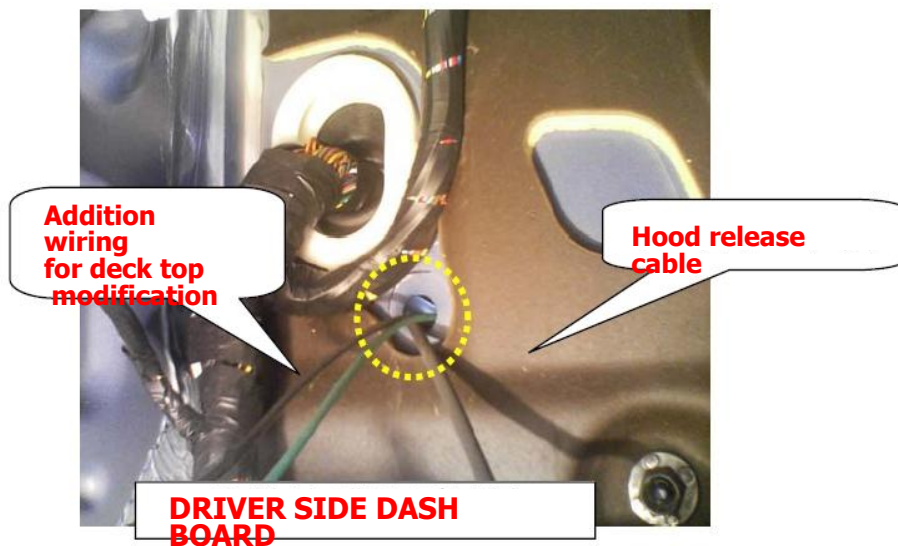
Engine noise come inside vehicle trough hole for rubber seal of hood release cable
Rubber seal of target vehicle was deleted because of deck top modificaion

If the rubber seal of hood release cable should be removed for certain purpose, you should block this hole using sealant or something

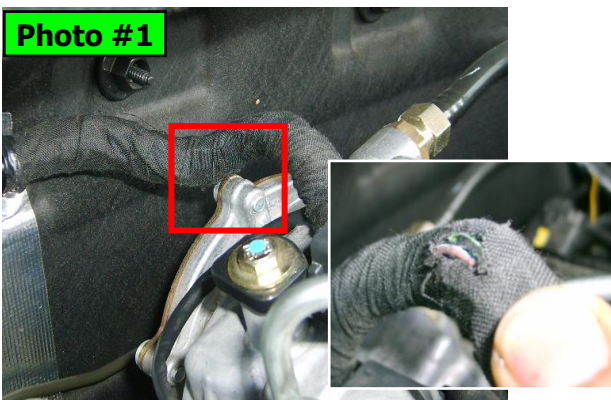
Wiring damage caused by engine running movement

Short circuit at decelerating

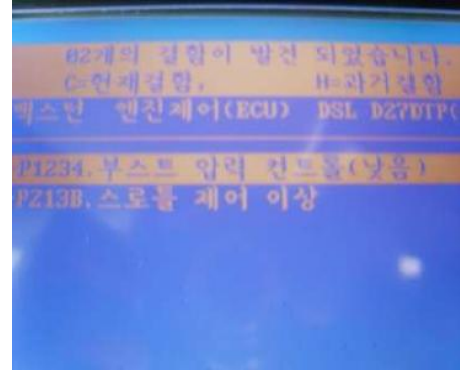
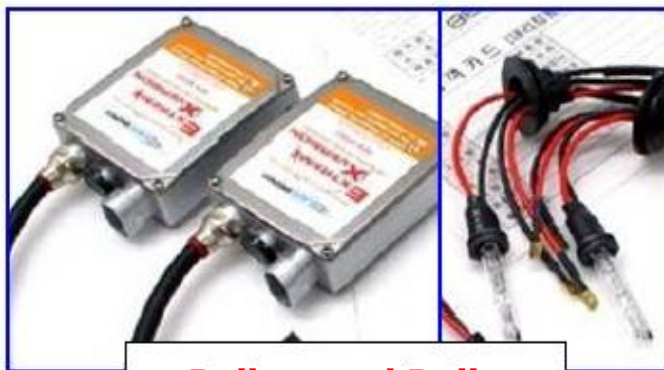
Ballast and Bulb

Unstable power source caused by HID modification
 (Symptom happens when head lamps turn ON)

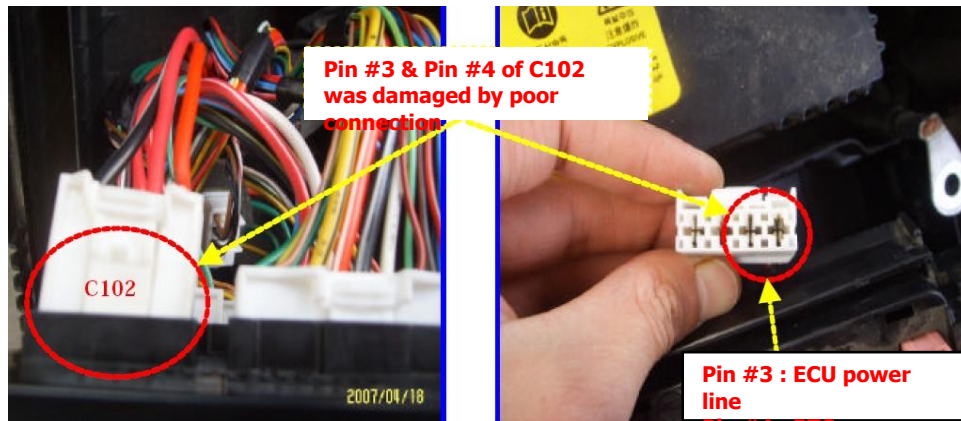
Engine intermittent not start caused by poor connection of C102 in engine room fuse box

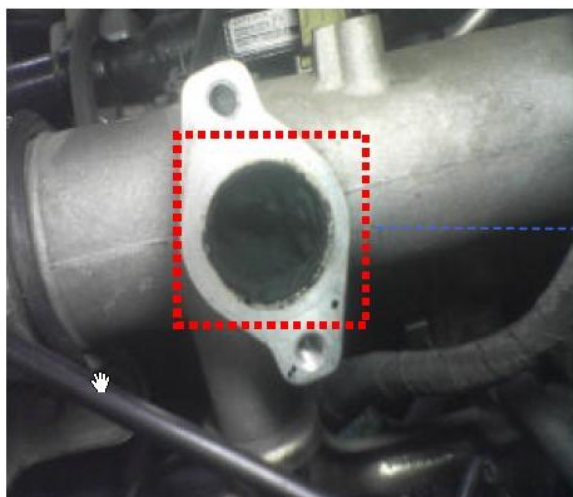
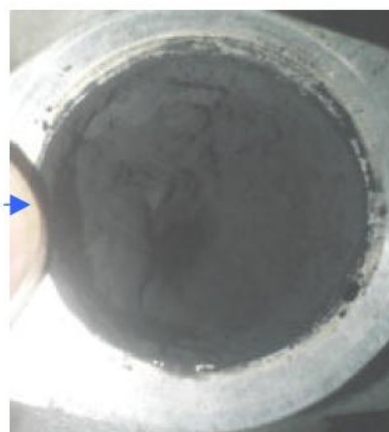
- A lot carbon deposit at intake manifold and EGR valve mounting area

EGR passage is block almost 90% by carbon

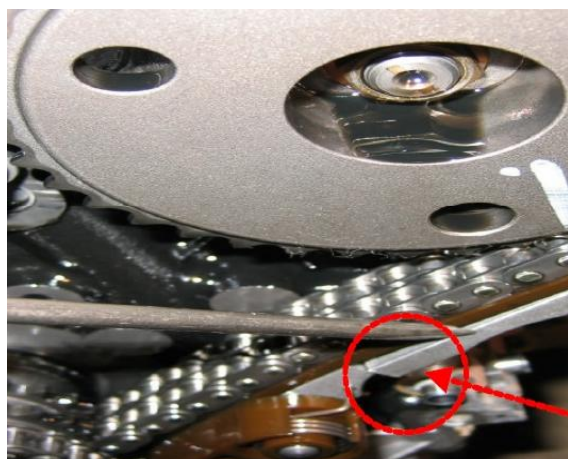
Damaged area

- Lossen timing chain and interference with head cover caused by lower guide rail assembly damage

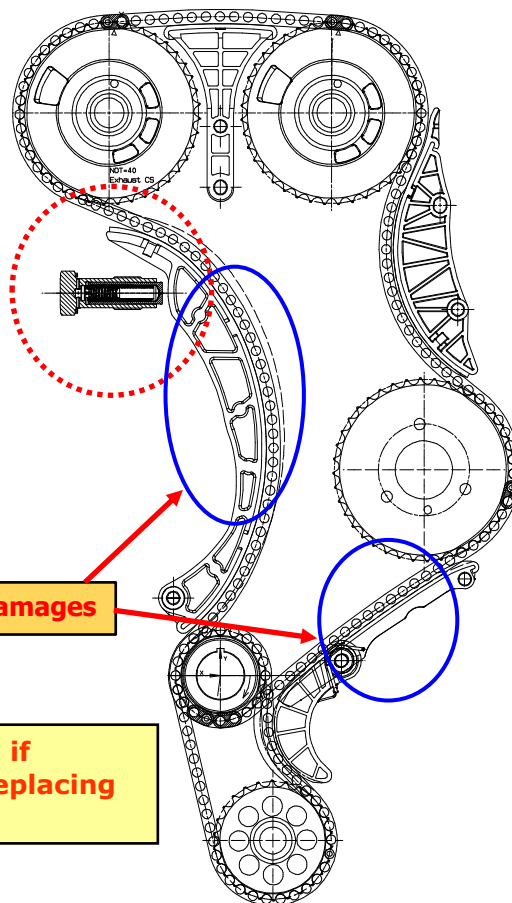
Check Damages

Check the sliding rail additionally if engine noise comes again after replacing chain tensioner

- Check the root cause according to below check procedure step by step
 1. Remove chain tensioner and check the tension of timing chain
 2. Remove cylinder head cover and check the damage inside head cover (especially area which located IN/EX camshaft sproket)
 3. Replace chain tensioner if there is damage mark inside cylinder head cover
Tightening Torque of chain tensioner : 65 Nm
 4. If the noise don't be cleared after new chain tensioner, please check damage on guide rails
; check the engine noise again at idle condition after replacing chain tensioner

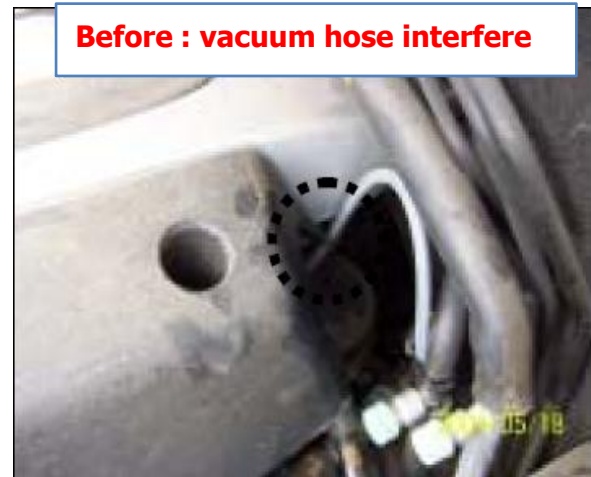
- Vacuum Hose for 4WD locking hub damage by interference with engine acoustic cover
→ EGR out of control by vacuum leakage
- ※ In case of vacuum leak, it effect EGR valve operation firstly

- Cut out the damaged vacuum hose and reconnect
- If necessary, replace vacuum hose

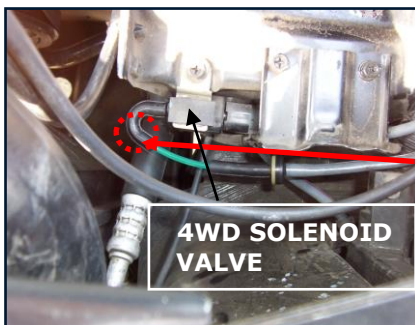
- Found 4WD solenoid valve vacuum hose crack
- Replace damaged vacuum hose

**vacuum leak
by hose**

Do not replace EGR vacuum modulator without inspection, should check vacuum pressure and find actual reason of problem correctly

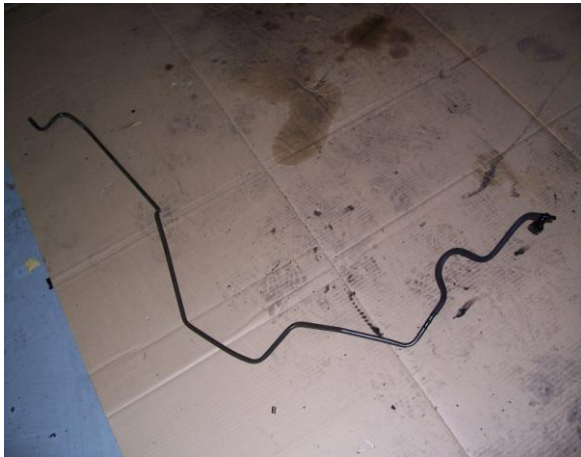
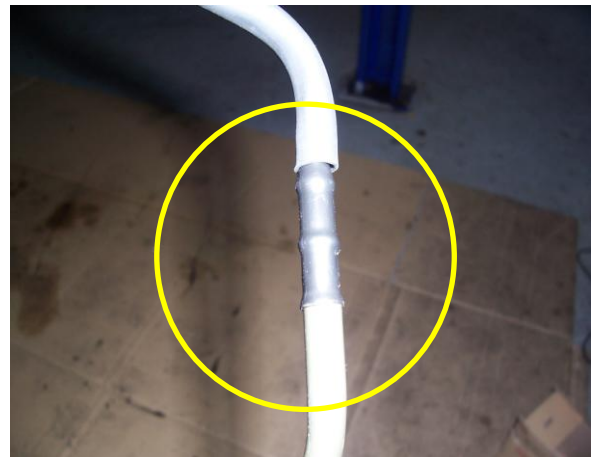
- Fuel leak from fuel return pipe

- Replace fuel return pipe with new one

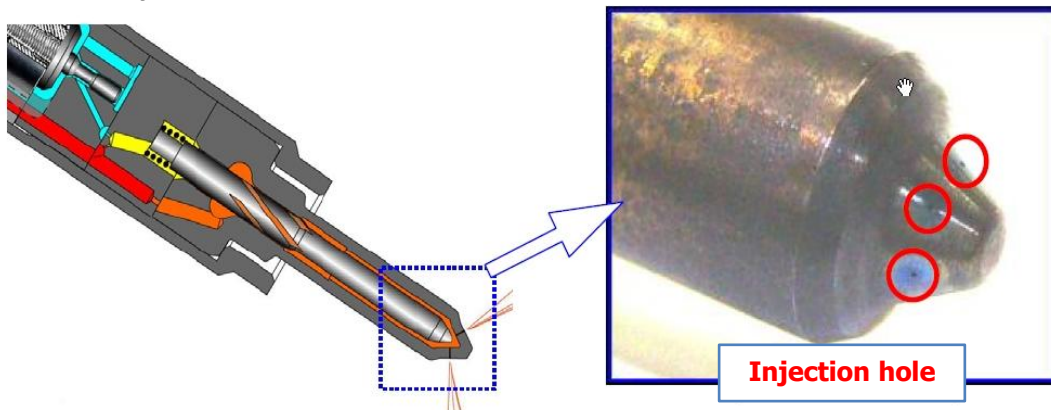
- Injector back leak test : OK
- Some corrosion on cylinder head by vehicle flooded

- Injection hole could be blocked in case of water intrusion into cylinder
- Injection hole could be blocked by engine oil in case of vehicle turn over
- No. of Injection hole (D27DT : 5EA, D20DT : 6EA, D27DPT : 7EA)

- Replace all 5 Injectors

- In case of blocked injection hole, its very difficult to troubleshooting ; Can't be detected by Injector back leak test
- In case of flooded vehicle or vehicle turn over, replace all Injector with new one
- In case of flooded vehicle, replace vacuum modulator at the same time.

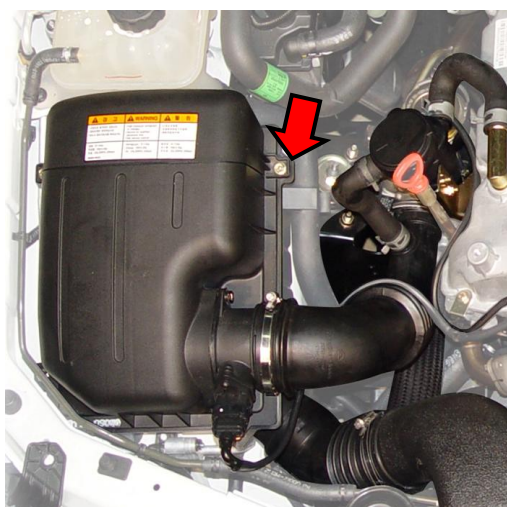
- **Symptom** : Wind noise from engine front side (intake manifold) at accelerating (over 1,500 RPM) caused by air cleaning housing leak due to poor workmanship while air cleaner replacement
- **Repair History** : No result after replacing Tharger, EGR valve and Vacuum Modulator several times
- **Possible Causes** : Unexpected air input casused by air cleaner housing leak
- **Troubleshooting** : Reinstall air cleaner housing (housing bolt tightening torque : 4.2 ~ 6.2 Nm)

- ✓ When air clear housing bolts are over tightened beyond specification, it could damage the nut of housing lower part and air leakage
- ✓ In case of mis-installation or installation of wrong part (ex, Rodius air clear element) ; housing will be get loose due to thickness difference

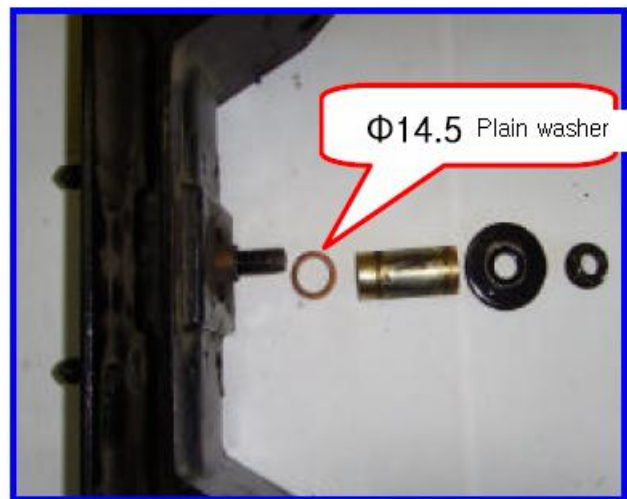
Interference noise between steel tube and washer

Insert plain washer after disassembling insulator

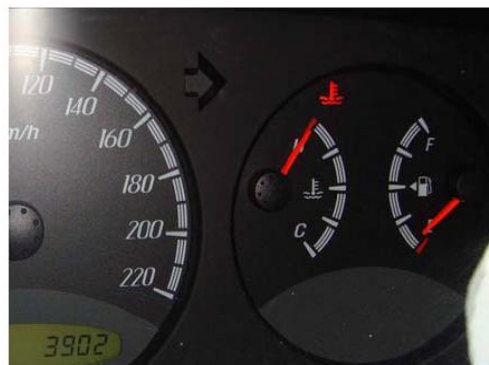
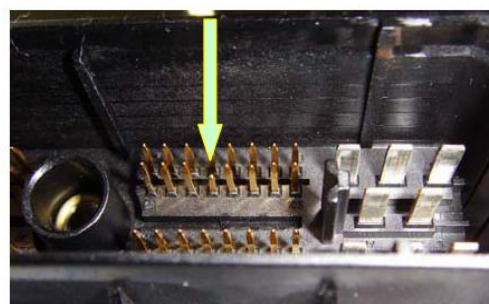
- 1) Coolant temperature gauge rises in sudden while driving
- 2) DTC (on ECU)
 - H-P0644 - CAN Cluster error
 - H-P0613 - TCU CAN data error
 - H-P1115 - Coolant temperature sensor error

Engine room wiring replaced
Coolant temperature sensor replaced
Cluster ground retightened
Trouble symptoms remain same

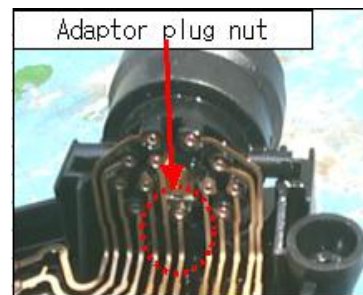
- Connection damaged by exterior vibration
- 7mm nut was stuck by high temperature
